Fence entirely made of iron with reinforced structure treated with Ferrus, a protective process that guarantees high resistance to corrosion.

Ref.	A	H
VVP005	3000	400

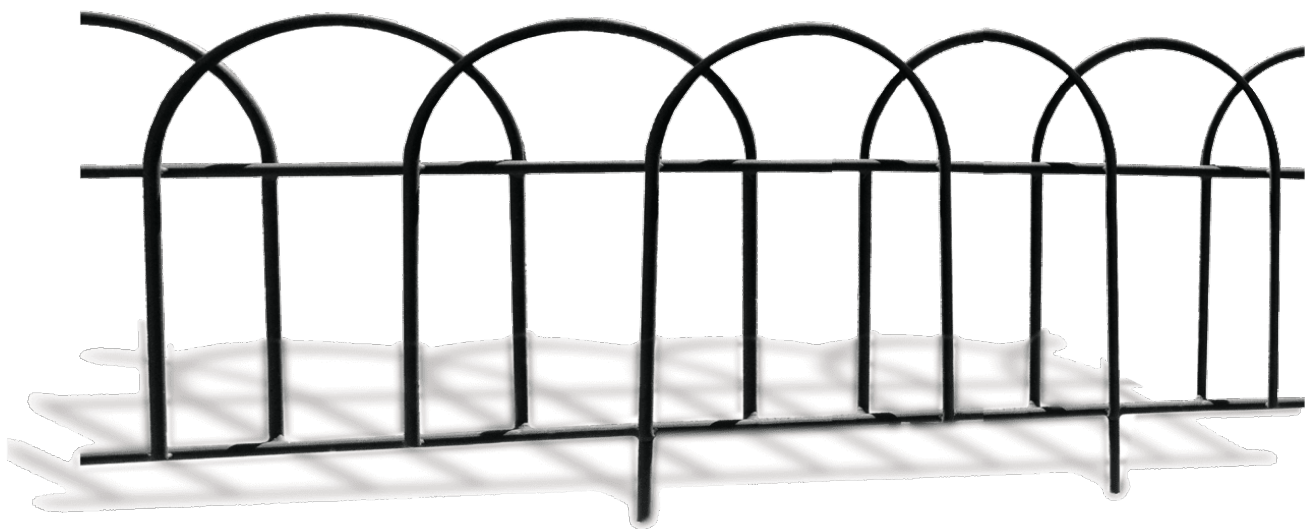
The Ferrus treatment consists of three layers applied after shot cleaning all impurities and an electrolytic bath, and an epoxy and forge black polyester paint coating.

Recommended anchoring: concrete foundation.
